## Boat-Wave-Induced Bank Erosion on the Kenai River, Alaska

Stephen T. Maynard, David S. Biedenharn, Craig J. Fischenich,  
and Jon E. Zufelt

March 2008

Final report

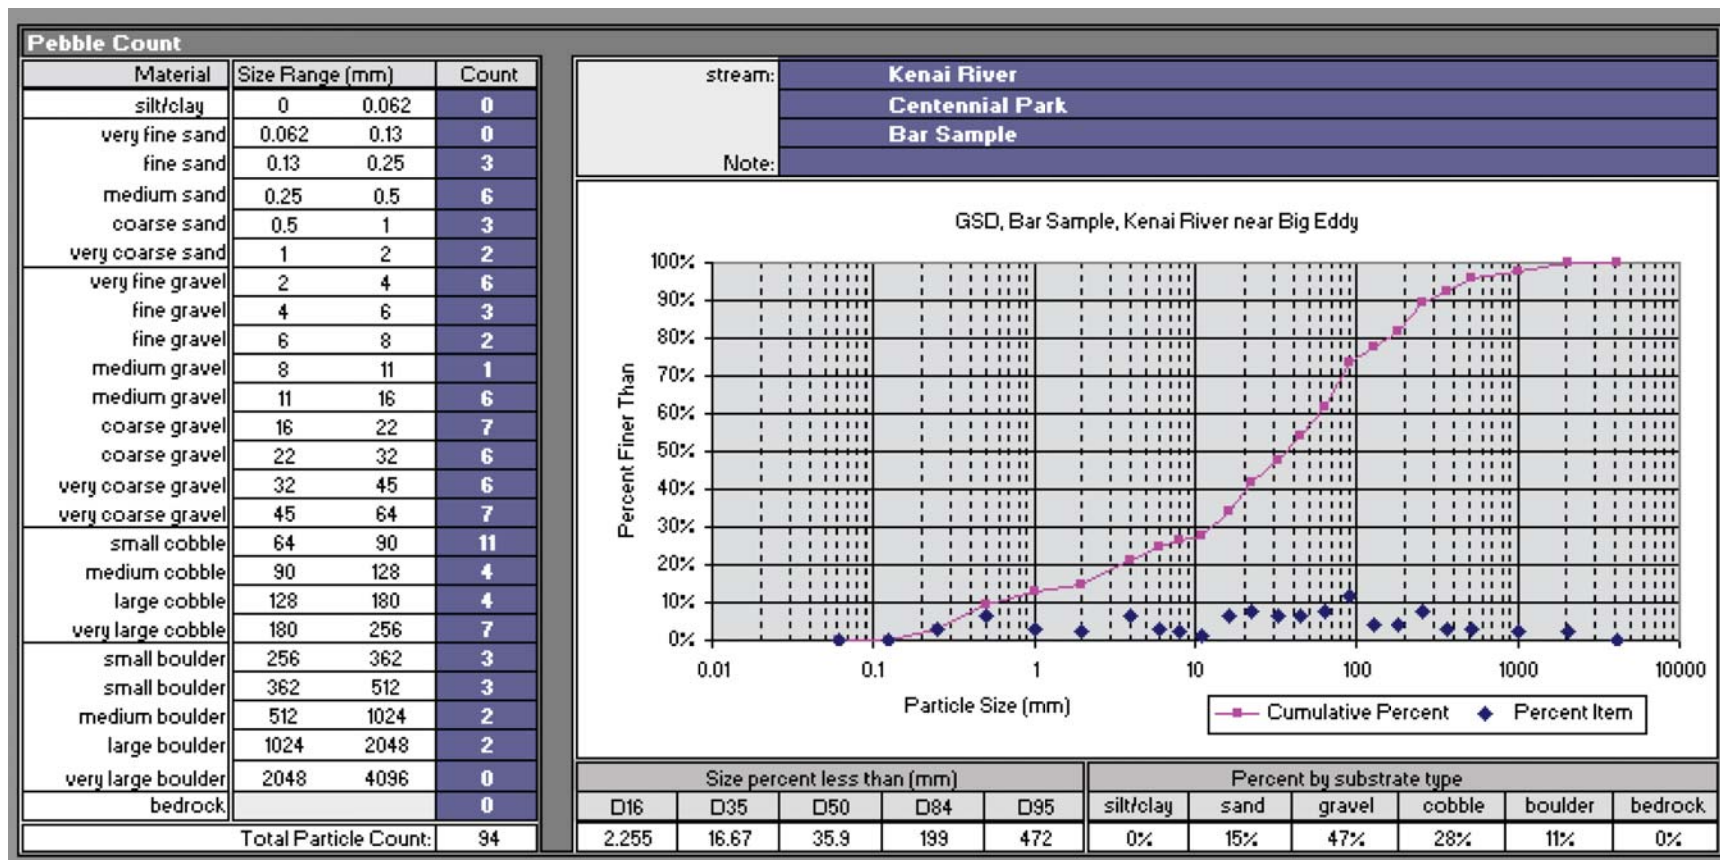
Figure B15. Bar sample of Kenai River (Centennial Park).

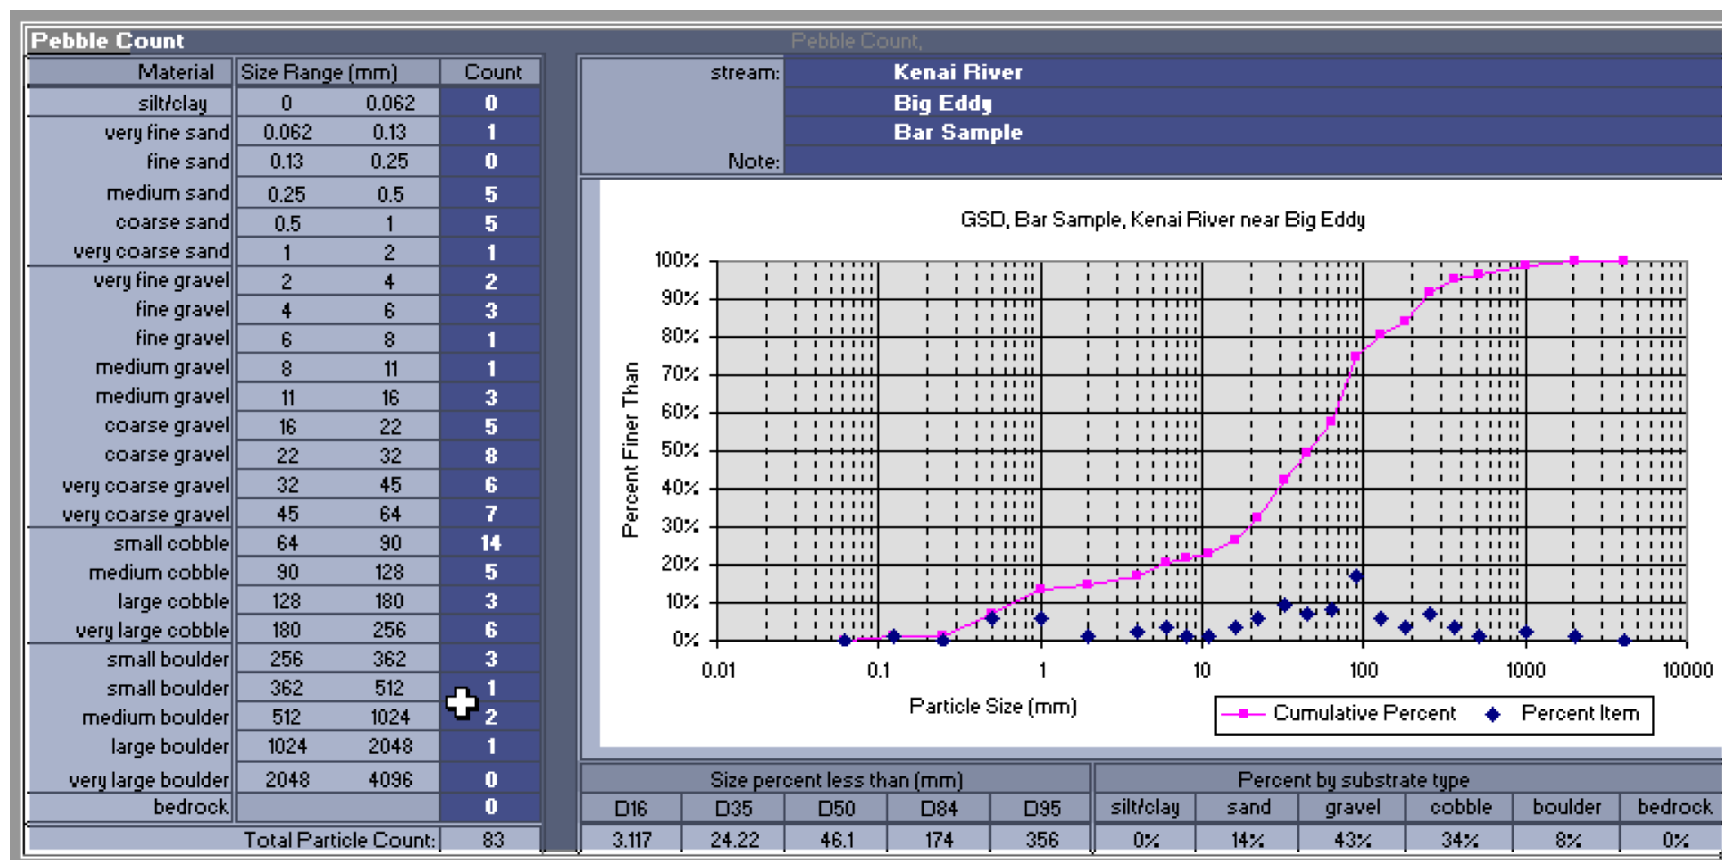
Figure B16. Bar sample of Kenai River (Big Eddy).

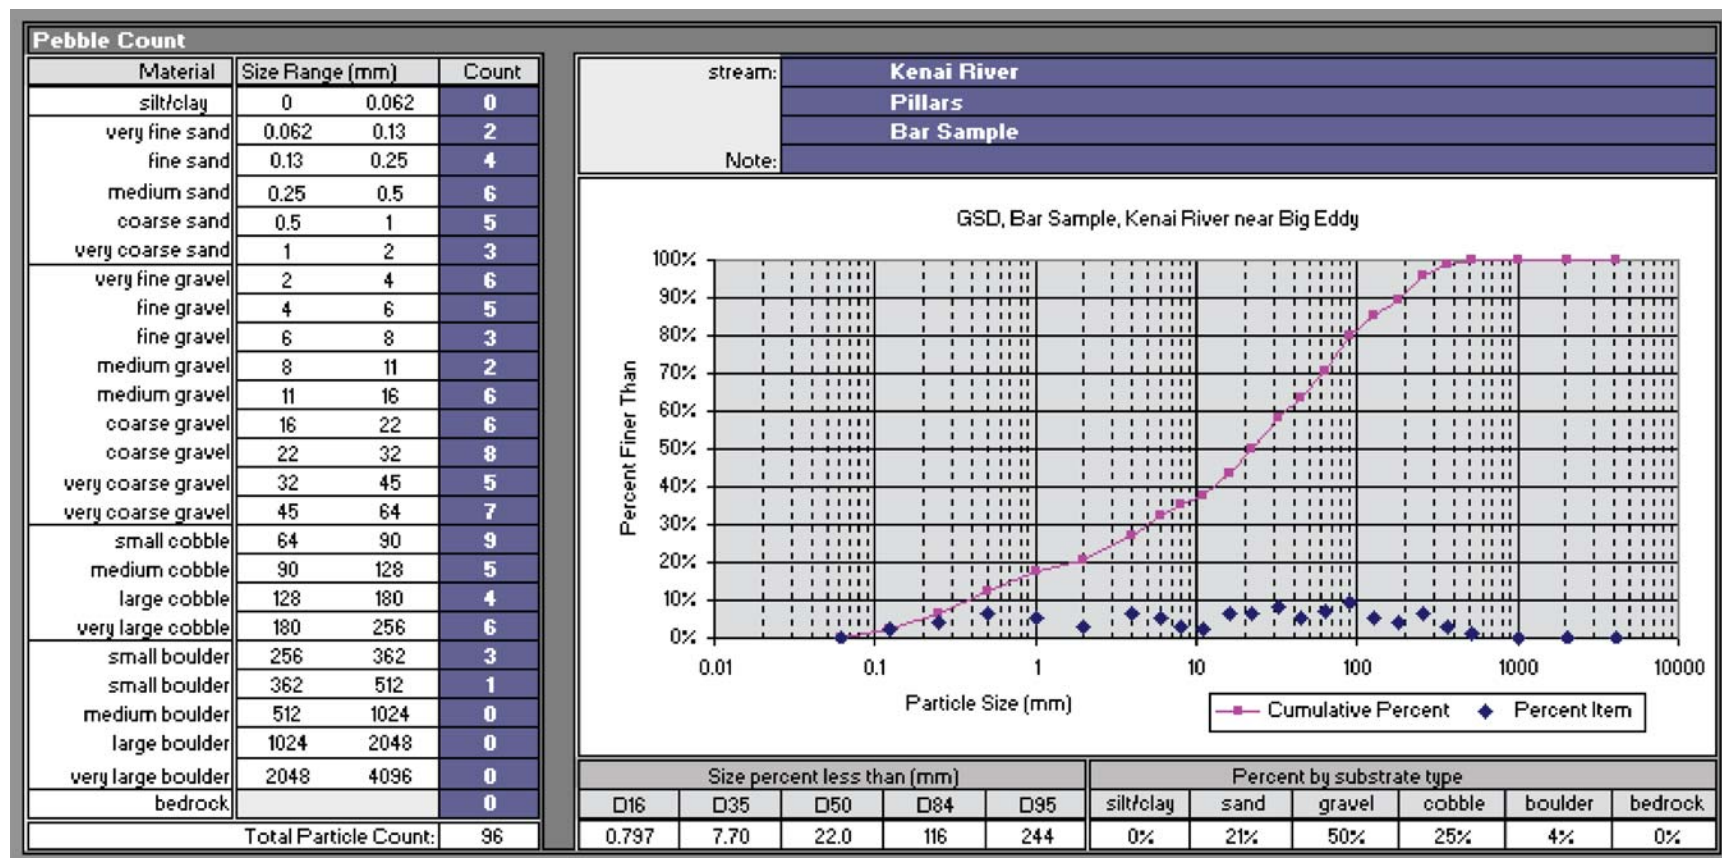
Figure B17. Bar sample of Kenai River (Pillars).
